DEPARTMENT OF TRANSPORTATION**DIVISION OF ENGINEERING SERVICES**

Contract #: 04-0120F4Cty: SF/ALA Rte: 80 PM: 13.2/13.9File #: 82.28**WELDING INSPECTION REPORT****Resident Engineer:**Siegenthaler, Peter**Address:** 333 Burma Road**City:** Oakland, CA 94607**Report No:** WIR-025415**Date Inspected:** 25-Jul-2011**Project Name:** SAS Superstructure**OSM Arrival Time:** 630**Prime Contractor:** American Bridge/Fluor Enterprises, a JV**OSM Departure Time:** 1500**Contractor:** Westmont Industries**Location:** Santa Fe Springs, CA**CWI Name:** Ruben Dominguez**CWI Present:** Yes No**Inspected CWI report:** Yes No N/A**Rod Oven in Use:** Yes No N/A**Electrode to specification:** Yes No N/A**Weld Procedures Followed:** Yes No N/A**Qualified Welders:** Yes No N/A**Verified Joint Fit-up:** Yes No N/A**Approved Drawings:** Yes No N/A**Approved WPS:** Yes No N/A**Delayed / Cancelled:** Yes No N/A**Bridge No:** 34-0006 L & R**Component:** Maintenance Travelers**Summary of Items Observed:**

SAS-WB Traveler – Lower Truss Frame Assembly

Final Coating Test performed by RPI Coating

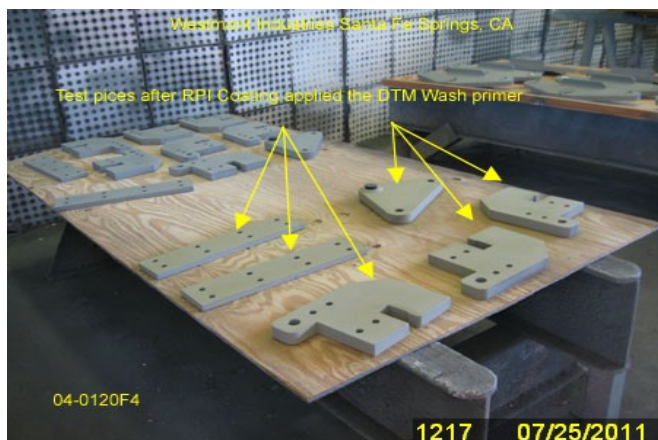
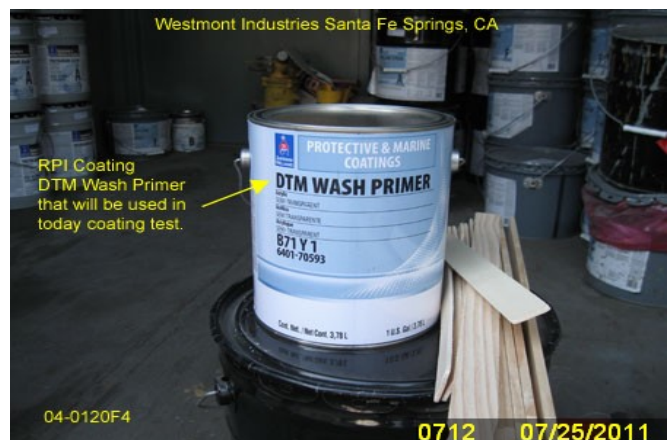
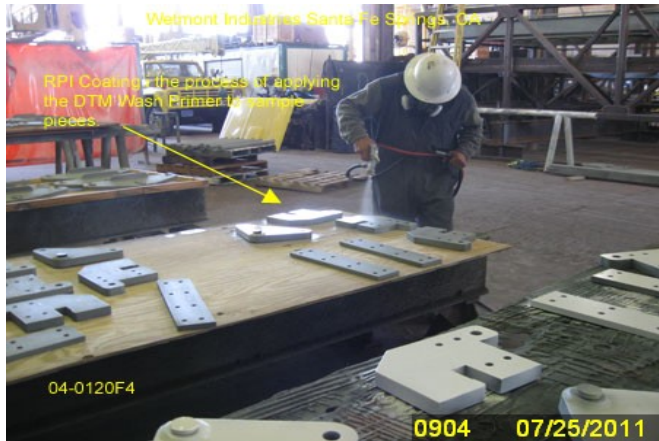
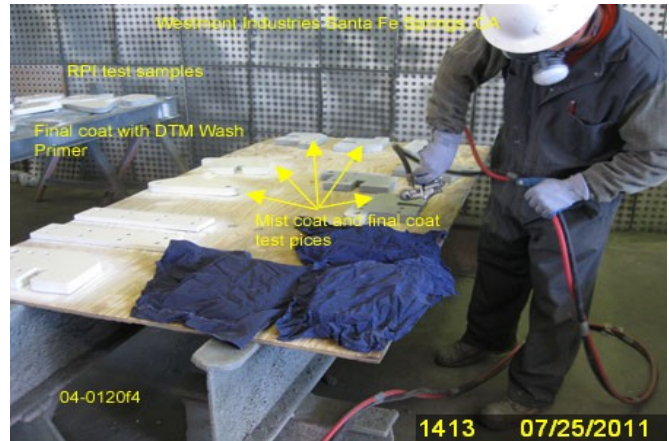
Later in the morning QA Inspection observed RPI Coating applying the Sherman Williams DTM Wash Primer to six (6) of the trolley links. QA Inspector observed no out gassing from the DTM Wash Prime.

Later in the afternoon QA met with Sherman Williams Representative Mr. Eric Anderson, Sherman Williams Technical Representative Mr. Carlos Gutierrez and RPI Coating Representative Mr. Gary McDonald and Mr. Carlos Torres. Mr. Torres informed QA Inspector that RPI is going to be performing various tests on the trolley links to try and determine the cause of the out gassing after applying final Polysiloxane Coating.

RPI Coating applied the Sherman Williams Polysiloxane XLE-80 Epoxy Siloxane using different methods; Final coating test are as follows:

3 test pieces with the DTM Wash Primer - Final coat – results – no gassing occurred.

2 test pieces - 1st - light mist coat, waited 15 minutes 2nd final coat – results – light out gassing occurred.

3 test pieces - 1st - light mist coat, waited 1 hour, 2nd – final coat – results – gassing occurred.

3 test pieces - 1st - light mist coat only. RPI did not complete testing.

After testing was completed RPI Coating Representative Mr. Gary McDonald and Mr. Carlos Torres informed QA Inspector Brannon that RPI Coating and Sherman Williams will discuss the outcome of today's tests and possibly submit an Request For Information (RFI) add the DTM Wash Prime Coat. QA Inspector informed Caltrans Representatives SMR Mr. Nicolai Hvass of the above information on this date.
